TECHNICAL REPORT REMR-CO-4

STABILITY OF DOLOS AND TRIBAR OVERLAYS
FOR REHABILITATION OF STONE-ARMORED
RUBBLE-MOUND BREAKWATER AND JETTY
TRUNKS SUBJECTED TO BREAKING WAVES

February 1988

Final Report

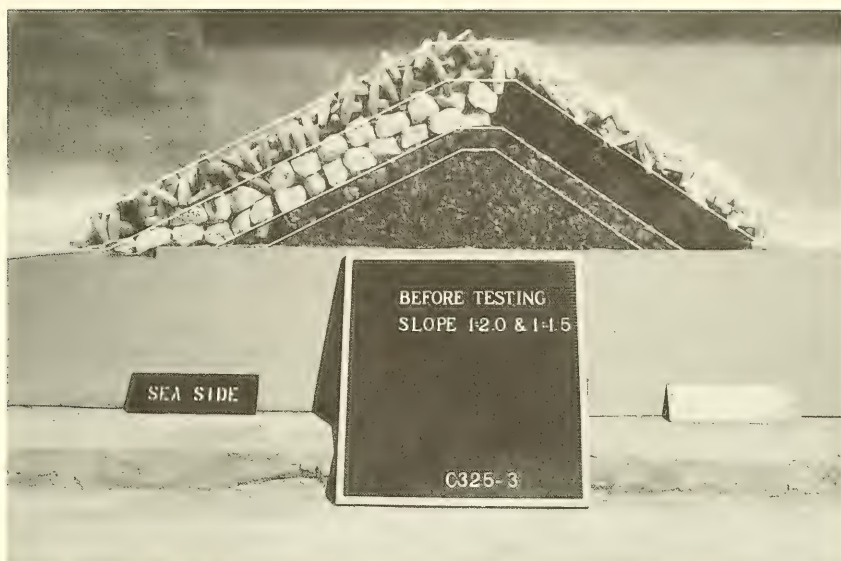
Photo 1. End view of a typical dolos section before wave attack at a 1V-on-2H sea-side structure slope; $W_a = 0.276 \text{ lb}$

17. All stability tests were conducted on sections of the type shown in Figure 1 and Photos 1-3. Sea-side slopes of 1V on 1.5H and 1V on 2H were investigated while the beach-side slope was held constant at 1V on 1.5H. Heights of the simulated existing structures (prior to placement of the dolos or tribar overlays) varied from 1.0 to 1.4 ft. The height necessary to prevent wave overtopping of the existing structure was determined from slopes and estimated water depths and wave heights to be investigated in determining stability coefficients (K'_D 's) for the dissimilar armor overlays.
